**REPORT ON CRIMINAL/TECHNICAL EXAMINATION OF THE SITE AT THE
"MARKALE" MARKET WHERE THE ARTILLERY PROJECTILE FELL**
- drafted by expert from the CSB /Security Services Centre/ Sarajevo
on 8 February 1994

ON THE CRIMINAL/TECHNICAL EXAMINATION OF THE ARTILLERY PROJECTILE FALL SITE AT THE "MARKALE" MARKET, MARŠALA TITA STREET, BY MIRZA SABLJICA, BALLISTICS EXPERT FROM THE CSB SARAJEVO - CRIMINAL/TECHNICAL AND KDZ /abbreviation unknown/ DEPARTMENT. A DIAGRAM AND PHOTO FILE HAVE ALSO BEEN MADE AND ARE AN INTEGRAL PART OF THIS REPORT

**STUDY OF CIRCUMSTANCES AND CAUSES OF THE MASSACRE AT
THE "MARKALE" MARKET ON 5 FEBRUARY 1995**

of circumstances and causes of the massacre
at the "Markale" market on 5 February 1994

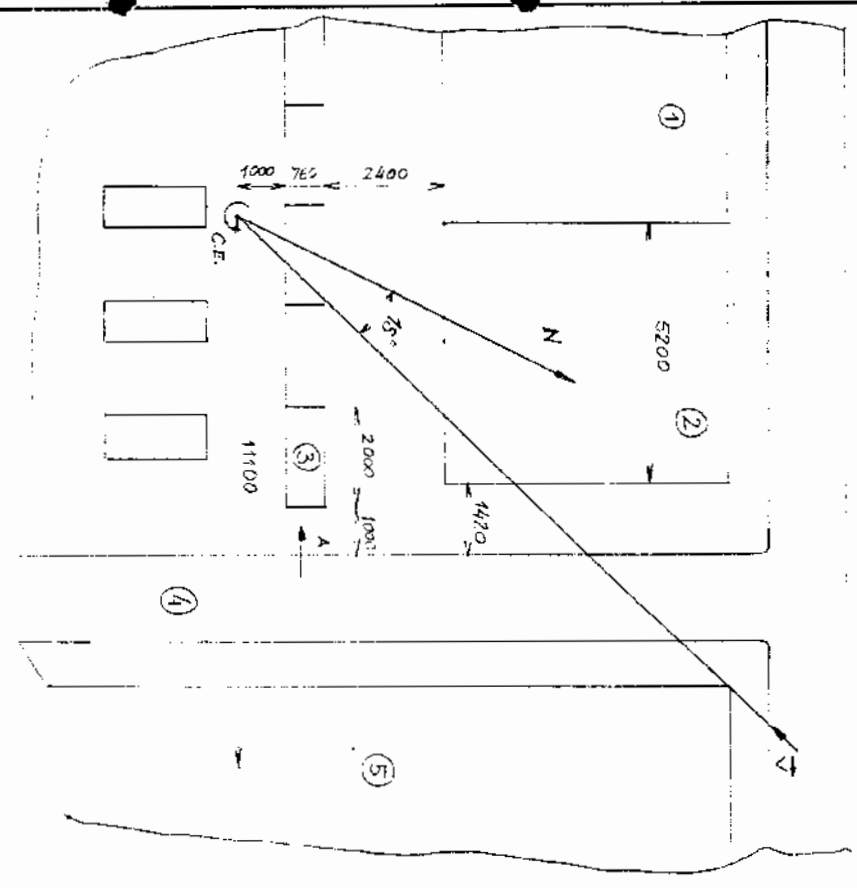
VIEW A

-
- 1) Supermarket UPI building, shop number 101, height of building = 5250 mm
 - 2) Supermarket UPI building, shop number 101, height of building = 3650 mm
 - 3) Market stall
 - 4) Street between the supermarket building and the "22 December" building
 - 5) "22 December" building, height of building = 15450 mm
- N - North
v - direction the projectile arrived from
C.E. Centre of explosion on the concrete surface

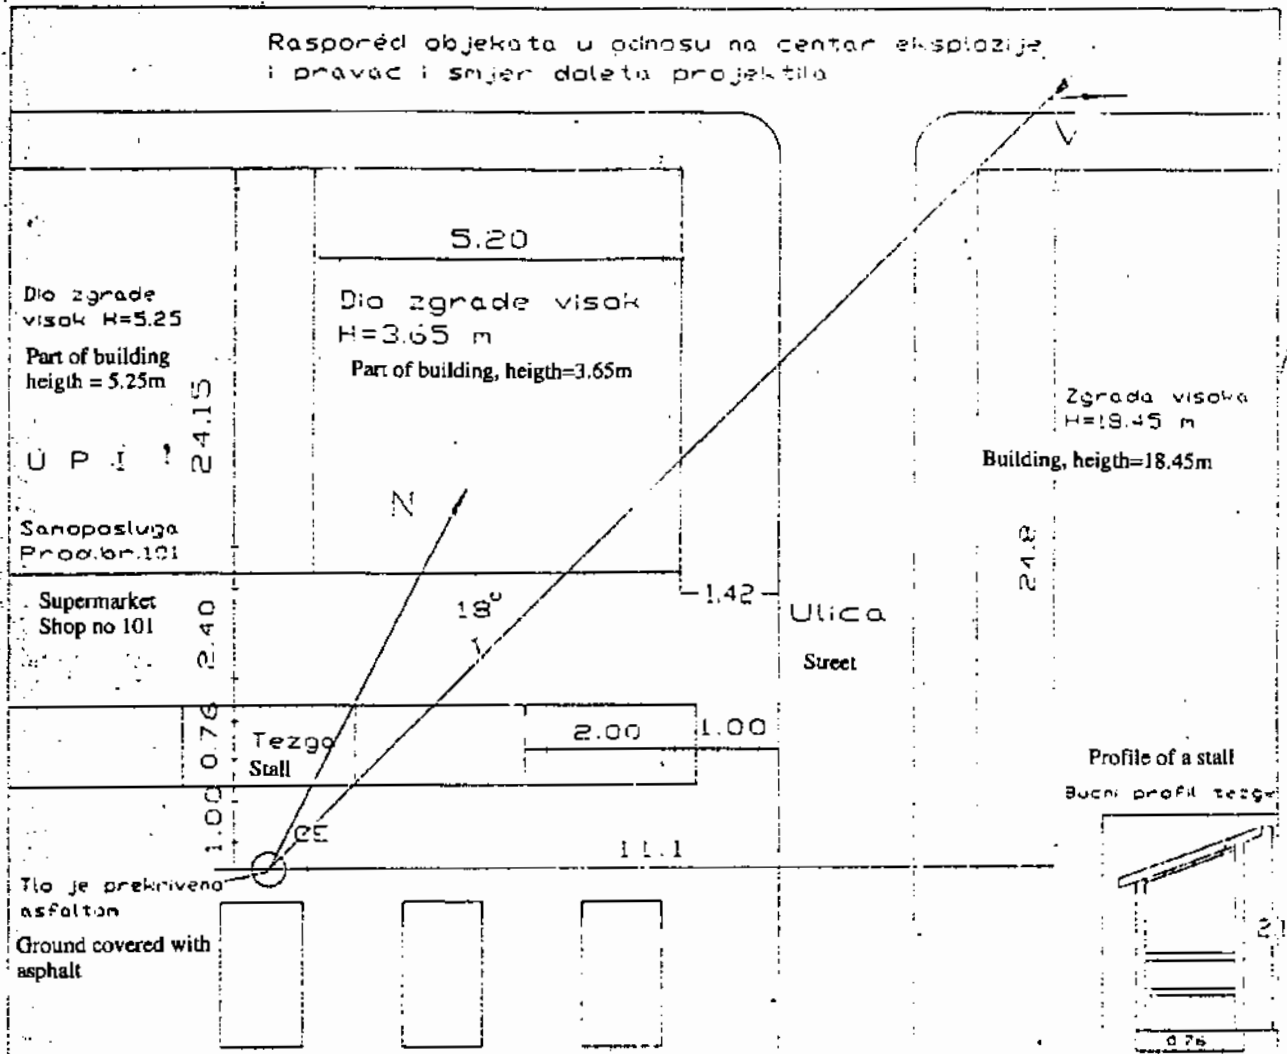
Picture 1. Position of buildings in relation to centre of explosion

Positioning of the buildings was measured in relation to the centre of the explosion (picture 1)
