**REPORT ON CRIMINAL/TECHNICAL EXAMINATION OF THE SITE AT THE
"MARKALE" MARKET WHERE THE ARTILLERY PROJECTILE FELL**
- drafted by expert from the CSB /Security Services Centre/ Sarajevo
on 8 February 1994

ON THE CRIMINAL/TECHNICAL EXAMINATION OF THE ARTILLERY PROJECTILE FALL SITE AT THE "MARKALE" MARKET, MARŠALA TITA STREET, BY MIRZA SABLJICA, BALLISTICS EXPERT FROM THE CSB SARAJEVO - CRIMINAL/TECHNICAL AND KDZ /abbreviation unknown/ DEPARTMENT. A DIAGRAM AND PHOTO FILE HAVE ALSO BEEN MADE AND ARE AN INTEGRAL PART OF THIS REPORT

**STUDY OF CIRCUMSTANCES AND CAUSES OF THE MASSACRE AT
THE "MARKALE" MARKET ON 5 FEBRUARY 1995**

of circumstances and causes of the massacre
at the "Markale" market on 5 February 1994

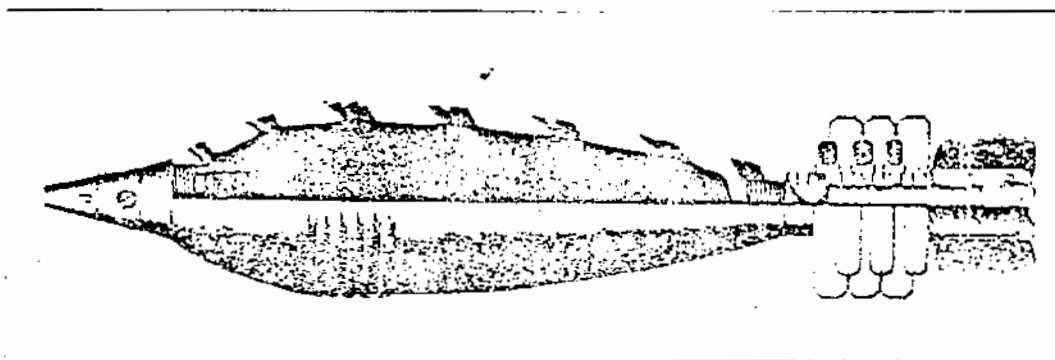
Drawing of a 120 mm M62P3 shell

- Mass of the projectile while flying	m = 12.6 kg
- Fuse (immediate and delayed detonation)	UTU M78
- Mass of the explosive (TNT)	m = 2.5 kg
- Mass of the casing	m = 8.7 kg
- Total length of the projectile with the fuse	l = 590 mm
- Basic charge (NGB-161 gunpowder)	m = 37 g
- Additional charge (NGB-261 gunpowder)	m = 6 x 76 g
- Maximum range of the shell fired from:	
- 120 mm UB M52 mortar	x = 6,050 m
- 120 mm M74 light mortar	x = 6,213 m
- 120 mm M75 light mortar	x = 6,340 m
